Contract #: 04-0120F4Cty: SF/ALA Rte: 80 PM: 13.2/13.9File #: 69.28**WELDING INSPECTION REPORT****Resident Engineer:**Pursell, Gary**Address:** 333 Burma Road**City:** Oakland, CA 94607**Report No:** WIR-016130**Date Inspected:** 03-Aug-2010**Project Name:** SAS Superstructure**OSM Arrival Time:** 1900**Prime Contractor:** American Bridge/Fluor Enterprises, a JV**OSM Departure Time:** 700**Contractor:** Zhenhua Port Machinery Company, Ltd (ZPMC), Changxing Island **Location:** Shanghai, China**CWI Name:** See Below**CWI Present:** Yes No**Inspected CWI report:** Yes No N/A**Rod Oven in Use:** Yes No N/A**Electrode to specification:** Yes No N/A**Weld Procedures Followed:** Yes No N/A**Qualified Welders:** Yes No N/A**Verified Joint Fit-up:** Yes No N/A**Approved Drawings:** Yes No N/A**Approved WPS:** Yes No N/A**Delayed / Cancelled:** Yes No N/A**Bridge No:** 34-0006**Component:** OBG**Summary of Items Observed:**

OBG Segment Trial Assembly

WELDING INSPECTION REPORT

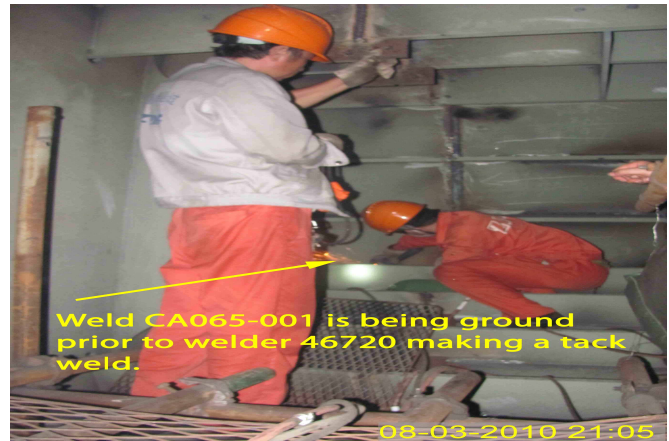
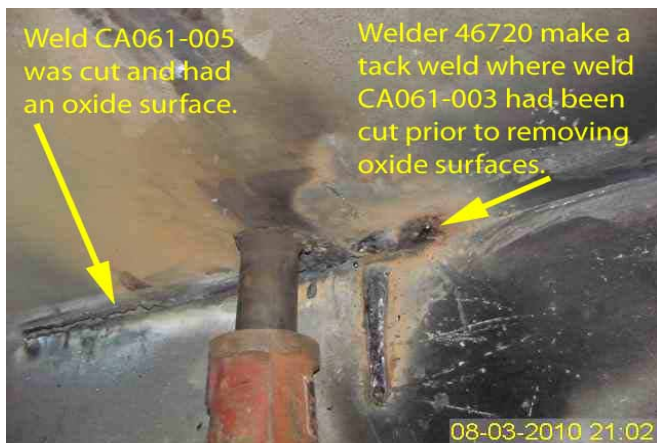
This QA Inspector observed ZPMC welder Mr. Guo Hui, stencil 046720 used shielded metal arc procedure WPS-B-P-2112-FCM-1 to make tack weld CA065-001. This hold back weld is located between the corner assembly side plate and the edge plate. This QA Inspector observed the area where one of the tack welds was deposited appears to have been flame cut and the flame cut oxide surfaces do not appear to have been ground to obtain a bright metal surface. This QA Inspector showed ZPMC QC Inspector Mr. Wang Zhu the flame cut area where the tack weld had been made and Mr. Wang Zhu informed this QA Inspector that he will ensure the tack weld is ground out and that the weld joint is ground to a bright metal condition prior to any additional welding. This QA Inspector observed the welding electrodes were being stored in a portable rod oven which was connected to an electric power cable. This QA Inspector measured a welding current of approximately 160 amps and Mr. Guo Hui appeared to be certified to make these tack welds. Items observed on this date do not fully appear to comply with applicable contract documents. See the photographs below for additional information.
